**REPORT & RECOMMENDATIONS
FOR**

**INITIAL DUDES-SNV-JSC JOINT ASSESSMENT
for Three Small Towns in Bhutan
Chukha district – Tsimasham, Tsimalakha and Gedu Towns**

(8-17 May 2011)

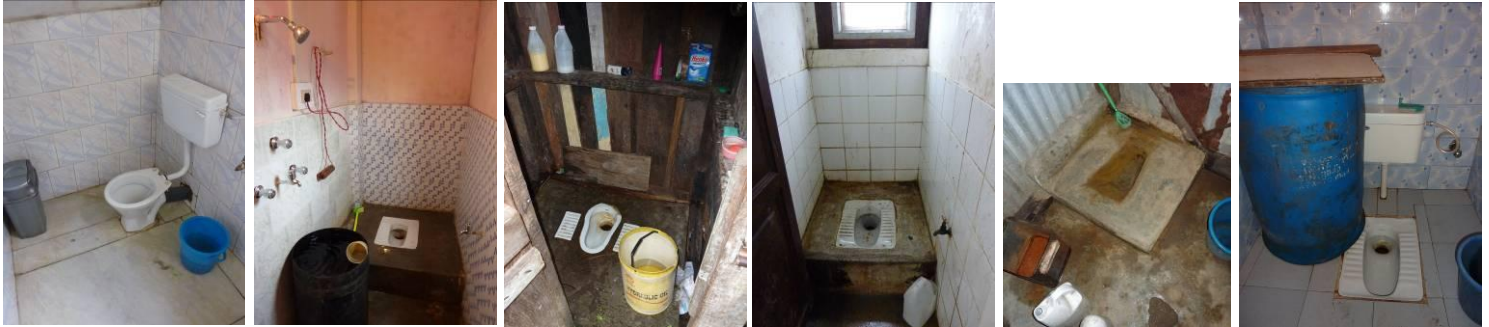
Figure 1: Observed types of toilet facilities in houses and public institutions

The observed types of toilet consisted of either a cistern flush system or a pour-flush system with a tap inside the cubicle or with access to water nearby. Water was often stored in barrels in the toilet area even for facilities equipped with cistern flush. This is used probably as a mitigation measure for flushing, cleaning or handwashing purposes when the piped-water supply is interrupted or when flushing mechanisms are not functioning.

Pedestal toilets and squat-down toilets are both quite common. The later type was made either of vitreous ceramic or cement mortar and mostly found in individual houses, while the former type was seen in restaurants or public institutions, such as the college in Gedu. In addition, it was positive to notice that most visited toilets in households or institutions allowed privacy, with a door that can be locked, even in the informal settlement visited in Gedu where home-made pour-flush latrines were constructed.

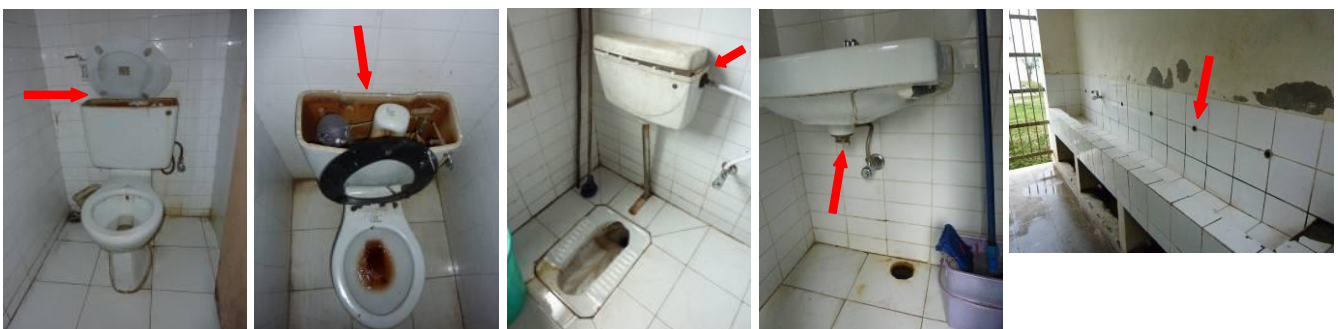
Figure 2: Example of toilet conditions observed in public institutions

Facilities in the visited school, college and hospital were reasonably clean but in state of serious disrepair, with many toilet fittings and equipment broken. This includes toilet seats often missing or broken; broken and non-functioning cistern flushing mechanisms; damaged or missing hand-washing taps - leaking or with no water supply; and issues with plumbing (connections missing, broken or leaking). These problems are potentially due to maintenance issues, improper use, and low quality parts.

Soap was rarely available in toilet areas, as well as waste bins. There were no specific provisions or bins for menstrual hygiene materials which sometimes resulted in improper disposal inside the toilet cubicle (e.g. in broken or non-functioning toilet cisterns in the college in Gedu).

While toilets are generally in good condition at household level, the situation is notably different in public institutions (i.e. in the visited school, college, hospital, and, in some cases, restaurants), where toilet equipment and fittings were often found broken. Although the equipment quality can be blamed, proper usage is an area where much improvement could be achieved through awareness-raising campaigns and public education.

As people are more likely to appreciate and use a clean and tidy toilet area, proper and timely cleaning is vital. Equally important is having a dependable system in place that ensures the regular maintenance of public facilities, and the timely repair of broken equipment and fittings. Also it will be important to establish a financing system for public toilet usage, especially in areas highly frequented by travelers.

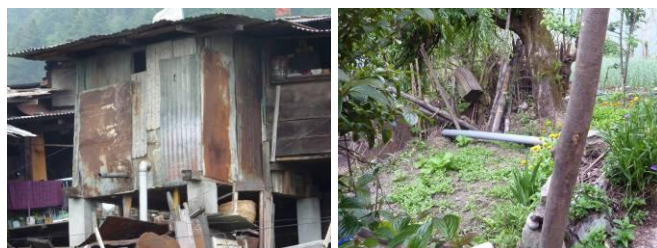
Figure 4: Improper wastewater discharge from toilet

The towns selected for this assessment are not – with the exception of a small area in Gedu town – covered by piped sewerage systems. Most of the inspected households and institutions were connected to septic tanks, and for some households coupled with soak pits (but rarely due to limited space inside the house plot boundary) or only connected to leach pits.

It was positive to discover that decentralized wastewater treatment systems are widely spread and compulsory with the construction of new buildings. However, even if wastewater effluent quality could not be assessed during this mission, septic tanks and soak pits' treatment efficiency can be questioned, as sludge collection is not systematically conducted yet and septage management is not yet organized. Current conditions ultimately lead to the discharge of accumulated sludge with the effluent, and/or the overflow of untreated wastewater when septic tanks are overloaded (during the mission, it was mentioned by municipal engineers that untreated wastewater from septic tanks was sometimes illegally removed and dumped into open drains at night). This is especially true for the shops in Tsimasham town, which sees many travelers stopping for a refreshment and/or toilet break. Overload can also frequently occur when the tanks are made too small in order to comply with the regulations for the minimum set-back distance of the septic tank from the plot boundary.

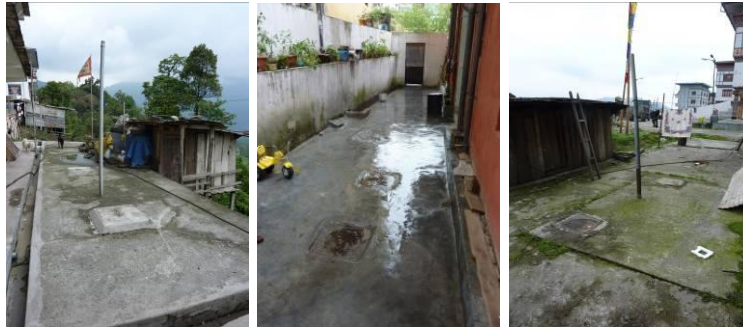
Figure 5: Examples of septic tanks

In the three visited towns, individual septic tanks were widely used. The latest standards/rules for construction require each new building to include a wastewater treatment system (i.e. a septic tank, when connection to a sewer network is not available). However, for this measure to be beneficial, treatment efficiency of septic tanks must be assured by consistent design, adequate capacity, consistent construction quality and proper maintenance. Some of the observed tanks varied in size, location inside the plot boundary, and vent pipe size varied widely from one septic tank to another.

The observed septic tanks were made of bricks, cement with mortar finish. From what was checked on the plan of a house under construction, the amount of cement used for the septic tank mortar finish (12 mm) was not thick enough to provide long lasting waterproofing. As a first step of improvement, it is advisable to replace bricks by a complete reinforced concrete structure.

The actual design of septic tanks – with sealed manhole covers – does not allow visual monitoring to assess sludge depth or conditions inside the tanks, nor easy desludging operations. Even if for security purposes manhole covers should be locked, they should also be maneuverable and not sealed.

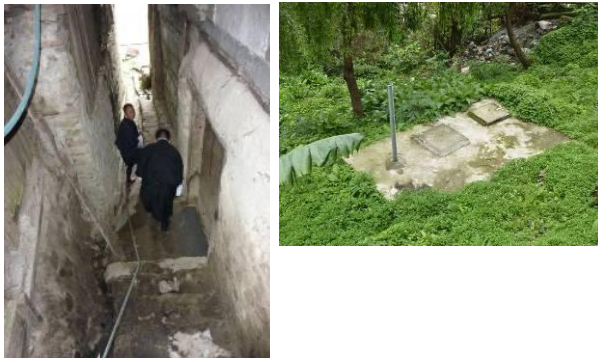
Figure 6: Difficulty of access to septic tanks

The observed individual septic tanks were mostly located in the backyards of houses, sometimes in positions difficult for accessing and emptying by a vacuum/cesspool truck.

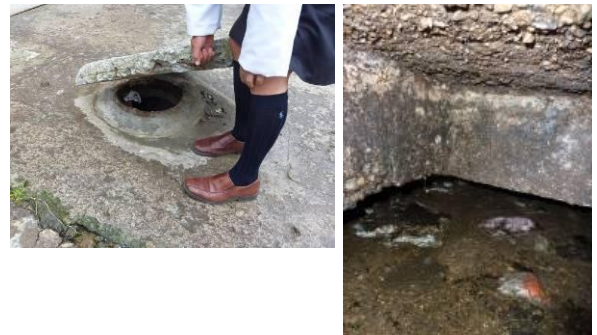
Figure 7: Issue with overload septic tanks and illegal dumping of untreated wastewater

Discussion with municipal staff showed that even when the design of the septic tank for a new building is approved by the municipal engineer, the facility constructed can sometimes be different. Due to shortage of building inspectors, the lack of verification of constructed facilities, and/or the weakness of enforcement in case of inappropriate construction, can partly explain why septic tanks with inconsistent design and insufficient capacity are still built. As mentioned earlier, the remaining space in a plot boundary after the house construction sometimes does not allow the implementation of a septic tank of appropriate size.

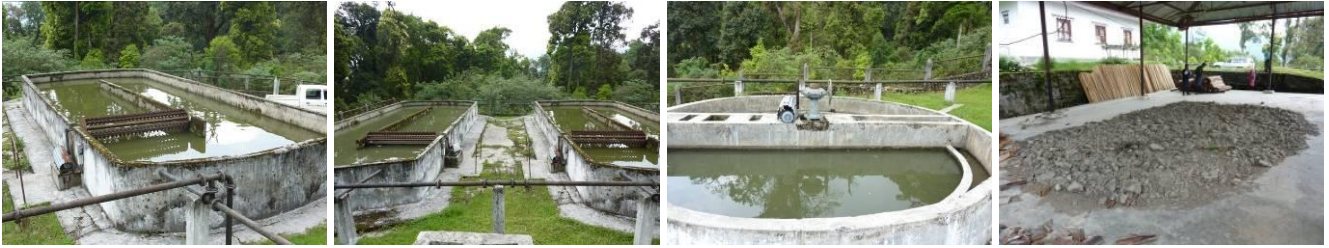
Figure 9: Sewage treatment plant in Gedu

The sewage treatment plant found in Gedu town was built in 1997 as part of the Tala Hydropower Project infrastructure. Implemented to serve the residential colony, this system covers approximately 200 households, and includes the Gedu College of Commerce and Business Studies and the hospital of Gedu. This plant, using activated sludge process, features two oxidation ditches, a sedimentation tank, and a sludge dewatering machine. This machine is installed inside an open-air steel frame building with roof and concrete floor, which is designed for sludge drying process after dewatering operation. Operation and maintenance is done by a caretaker and his wife, living in a house built on site. According to the plan of the plant that our team was shown, there is a small room for a laboratory in the caretaker's quarters.

At the time of the visit, the dewatering machine was out of order and no schedule was mentioned for repair. As indicated earlier, the rotor of the oxidation ditches was not operated continuously nor the scraper bridge of the sedimentation tank. A discussion with the caretaker's wife indicated that the intermittent operation was not for energy saving purpose. If the system would be operated constantly, the plant could offer better wastewater treatment efficiency. However, better treatment quality would only be necessary if the present effluent quality fails to meet the RGoB standard for final effluent from Sewerage Treatment Plants. If not met, the actual management could signify a lack of awareness in operation and maintenance and/or, more importantly, in the sewage treatment process. In that case, it would be unfortunate that the plant is not being used to its full potential due to poor operation.

From the monitoring of effluent's quality, it is important to confirm whether Bhutan's standard for final effluent is met or not. If not, current practices for operation could be improved through the provision of operation manuals, staff training and activities to raise awareness on sewage treatment process and knowledge on operation and maintenance. Maintenance will need to be addressed, as broken equipment and wearing infrastructure were observed. A maintenance schedule and capacity building to address these issues may be required.

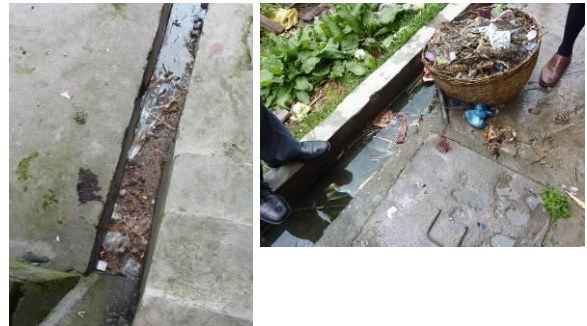
Figure 15: House drains blocked by garbage

Some of the drains observed were blocked by garbage or broken by trucks parking in unauthorized areas. Drain capacity or length in some of the visited areas seemed insufficient. These problems combined together could lead to overflowing drains in the event of heavy rainfall, and cause a serious public health risk especially during the monsoon period.

The accumulation of garbage was also observed in the drains of some houses, causing stagnant grey water.

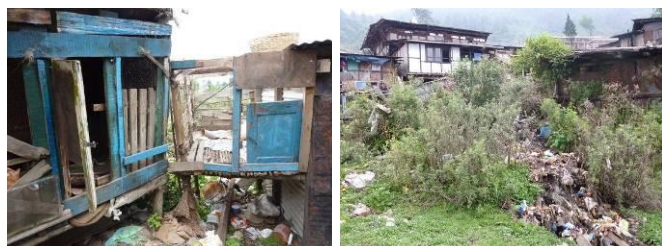
Figure 17: improper disposal of waste in house backyards

Other types of collection points for garbage disposal (e.g. bins) could hardly be found in towns, which may partly explain why littering or inadequate disposal of waste is common, especially in drains and on open land behind houses. This widespread practice shows that health hazards are not associated with this careless practice, thus highlighting the need for hygiene awareness activities and for establishing the habit of gathering garbage and bringing it to designated collection points. Conscious of the problem, the Chukha district authorities have recently initiated a collective cleaning operation organized every Saturday in which shop-keepers are required to clean up the town. This is an excellent example that can help to contribute to improving the current situation and changing people's behavior.

To establish safe and hygienic living conditions, the first step of improvement is to establish a behavior of organized disposal (whatever the amount is), and eradicate the wide spread habit of indiscriminate throwing away and littering in non-dedicated areas: backyard of houses, drains, etc. Hygiene promotion and communication campaigns with the public will here play an important role to raise awareness on the health risks and other negative consequences associated with current practices.

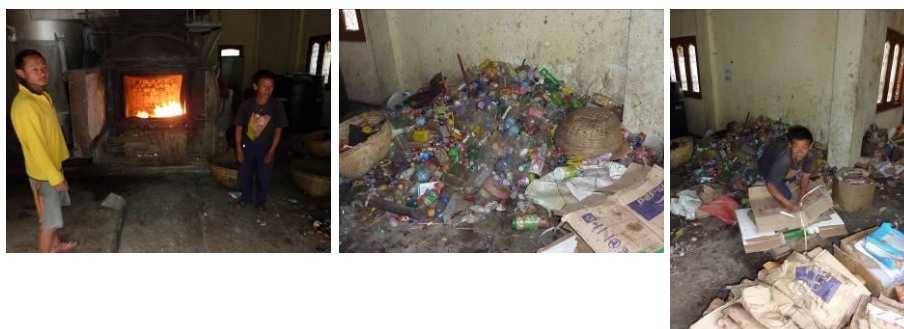
Figure 22: Combustion chamber and working conditions

Originally built as part of the Tala Hydropower Project infrastructure, the Alikha incinerator treats the garbage gathered from the six collecting points of Gedu town. It is managed by two operators and one supervisor. This facility has been recently out of use for six months and a large accumulation of garbage was seen on the receiving ramp above the waste sorting bay. Organic waste is left on the ground and is not protected from rainwater nor disposed. This is a potential source of ground contamination as wastewater infiltrates the soil without treatment. Due to the accumulation of garbage below the receiving ramp, waste segregation is not conducted there anymore, and the garbage collection truck dumps garbage directly in front of the incinerator where some selective segregation is done, but without any protective equipment. Cardboard is bundled up and plastic bottles are removed by the operators. Accumulated garbage inside the operating building causes unsanitary conditions for workers, which are made worse by the massive presence of flies.

As for the infrastructure, the furnace chimney is deteriorated by corrosion and now ends below the roof, which allows part of the smoke to circulate in the building, resulting in obnoxious smell and hazardous respiratory conditions for the workers. The temperature of combustion appeared to be quite low at the time of the visit, and staff refresher training will probably be beneficial to enable the use of the Alikha incinerator to its full potential.

It is firstly important to improve the working conditions and take strict safety measures for the staff operating the incinerator. This includes the provision of facemasks, protective clothing, gloves, boots, and measures such as pesticides to limit the presence of flies and other insects at the site.

These measures include a quick repair or replacement of the corroded chimney stack. This would prevent the smoke from entering the operating area and improve combustion efficiency. To improve working conditions inside the operating room, waste segregation should also be done at its originally designed area: the sorting bay below the receiving ramp.
